**Donegal Stud Residential Subdivision Stage 10A at
84 Thomas Road, Flat Bush**

Geotechnical Completion Report
GENZAUCK16856AB

24 September 2018

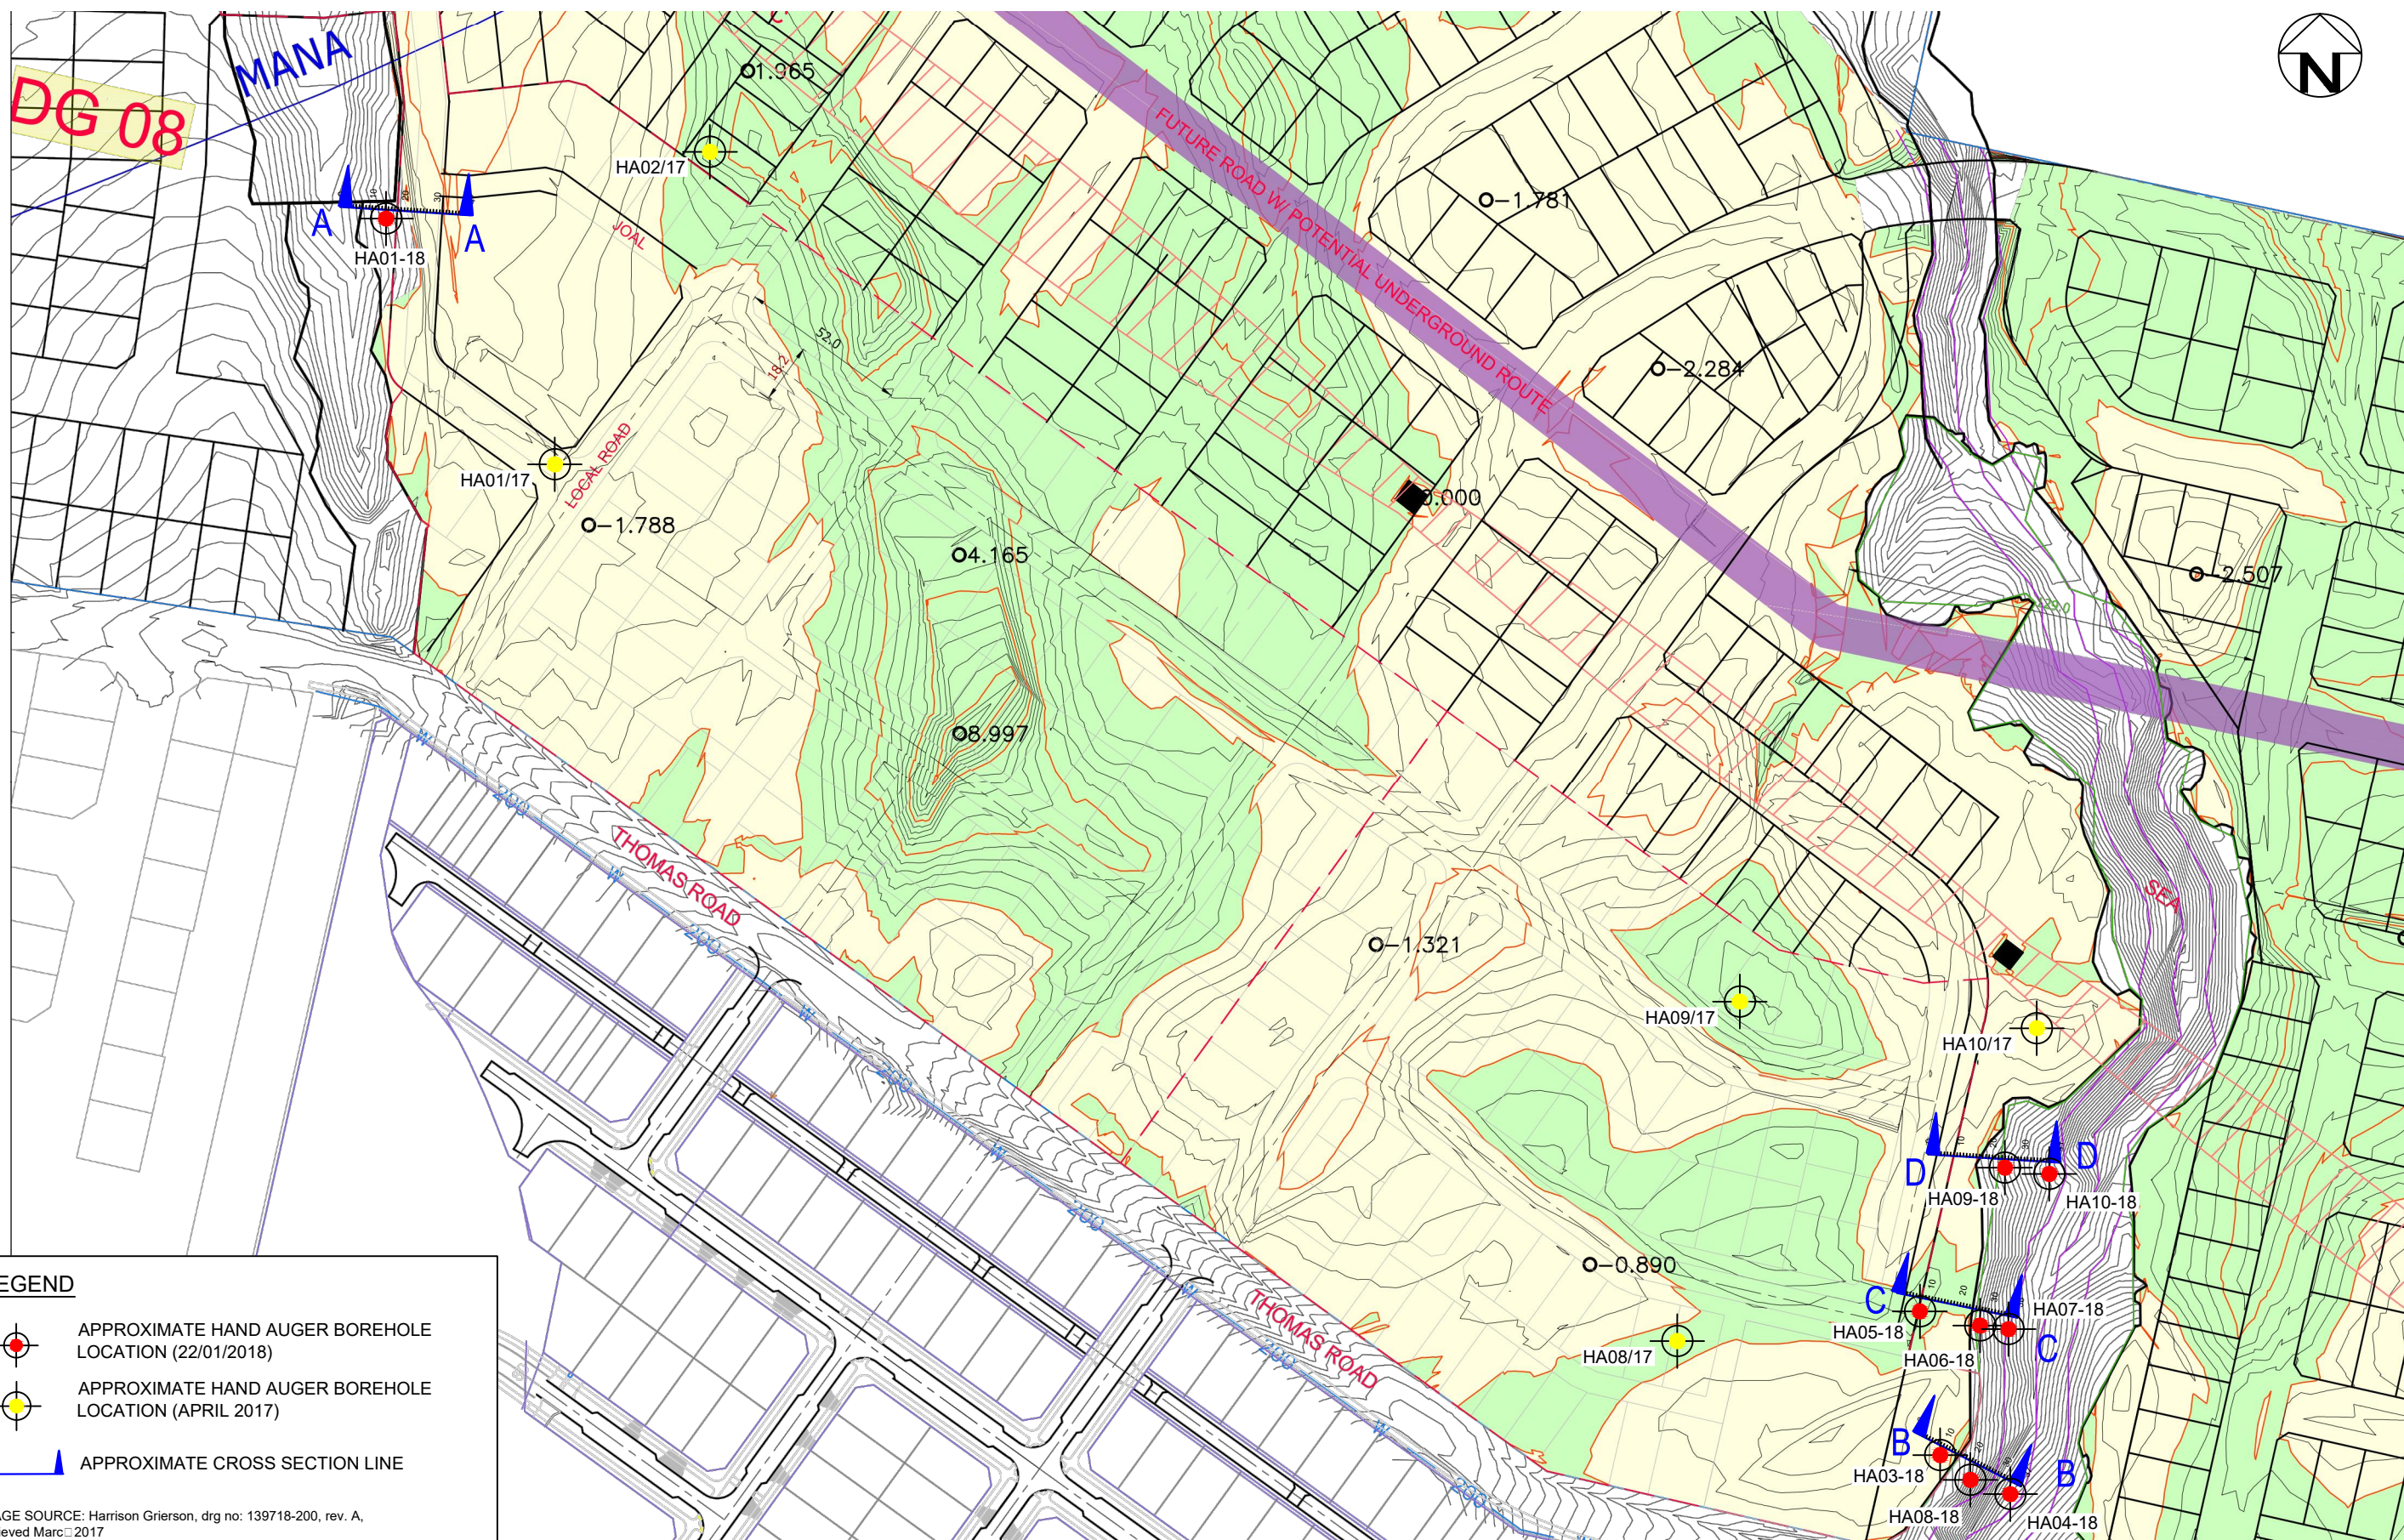
- LEGEND**
- APPROXIMATE HAND AUGER BOREHOLE LOCATION (22/01/2018)
 - APPROXIMATE HAND AUGER BOREHOLE LOCATION (APRIL 2017)
 - APPROXIMATE CROSS SECTION LINE

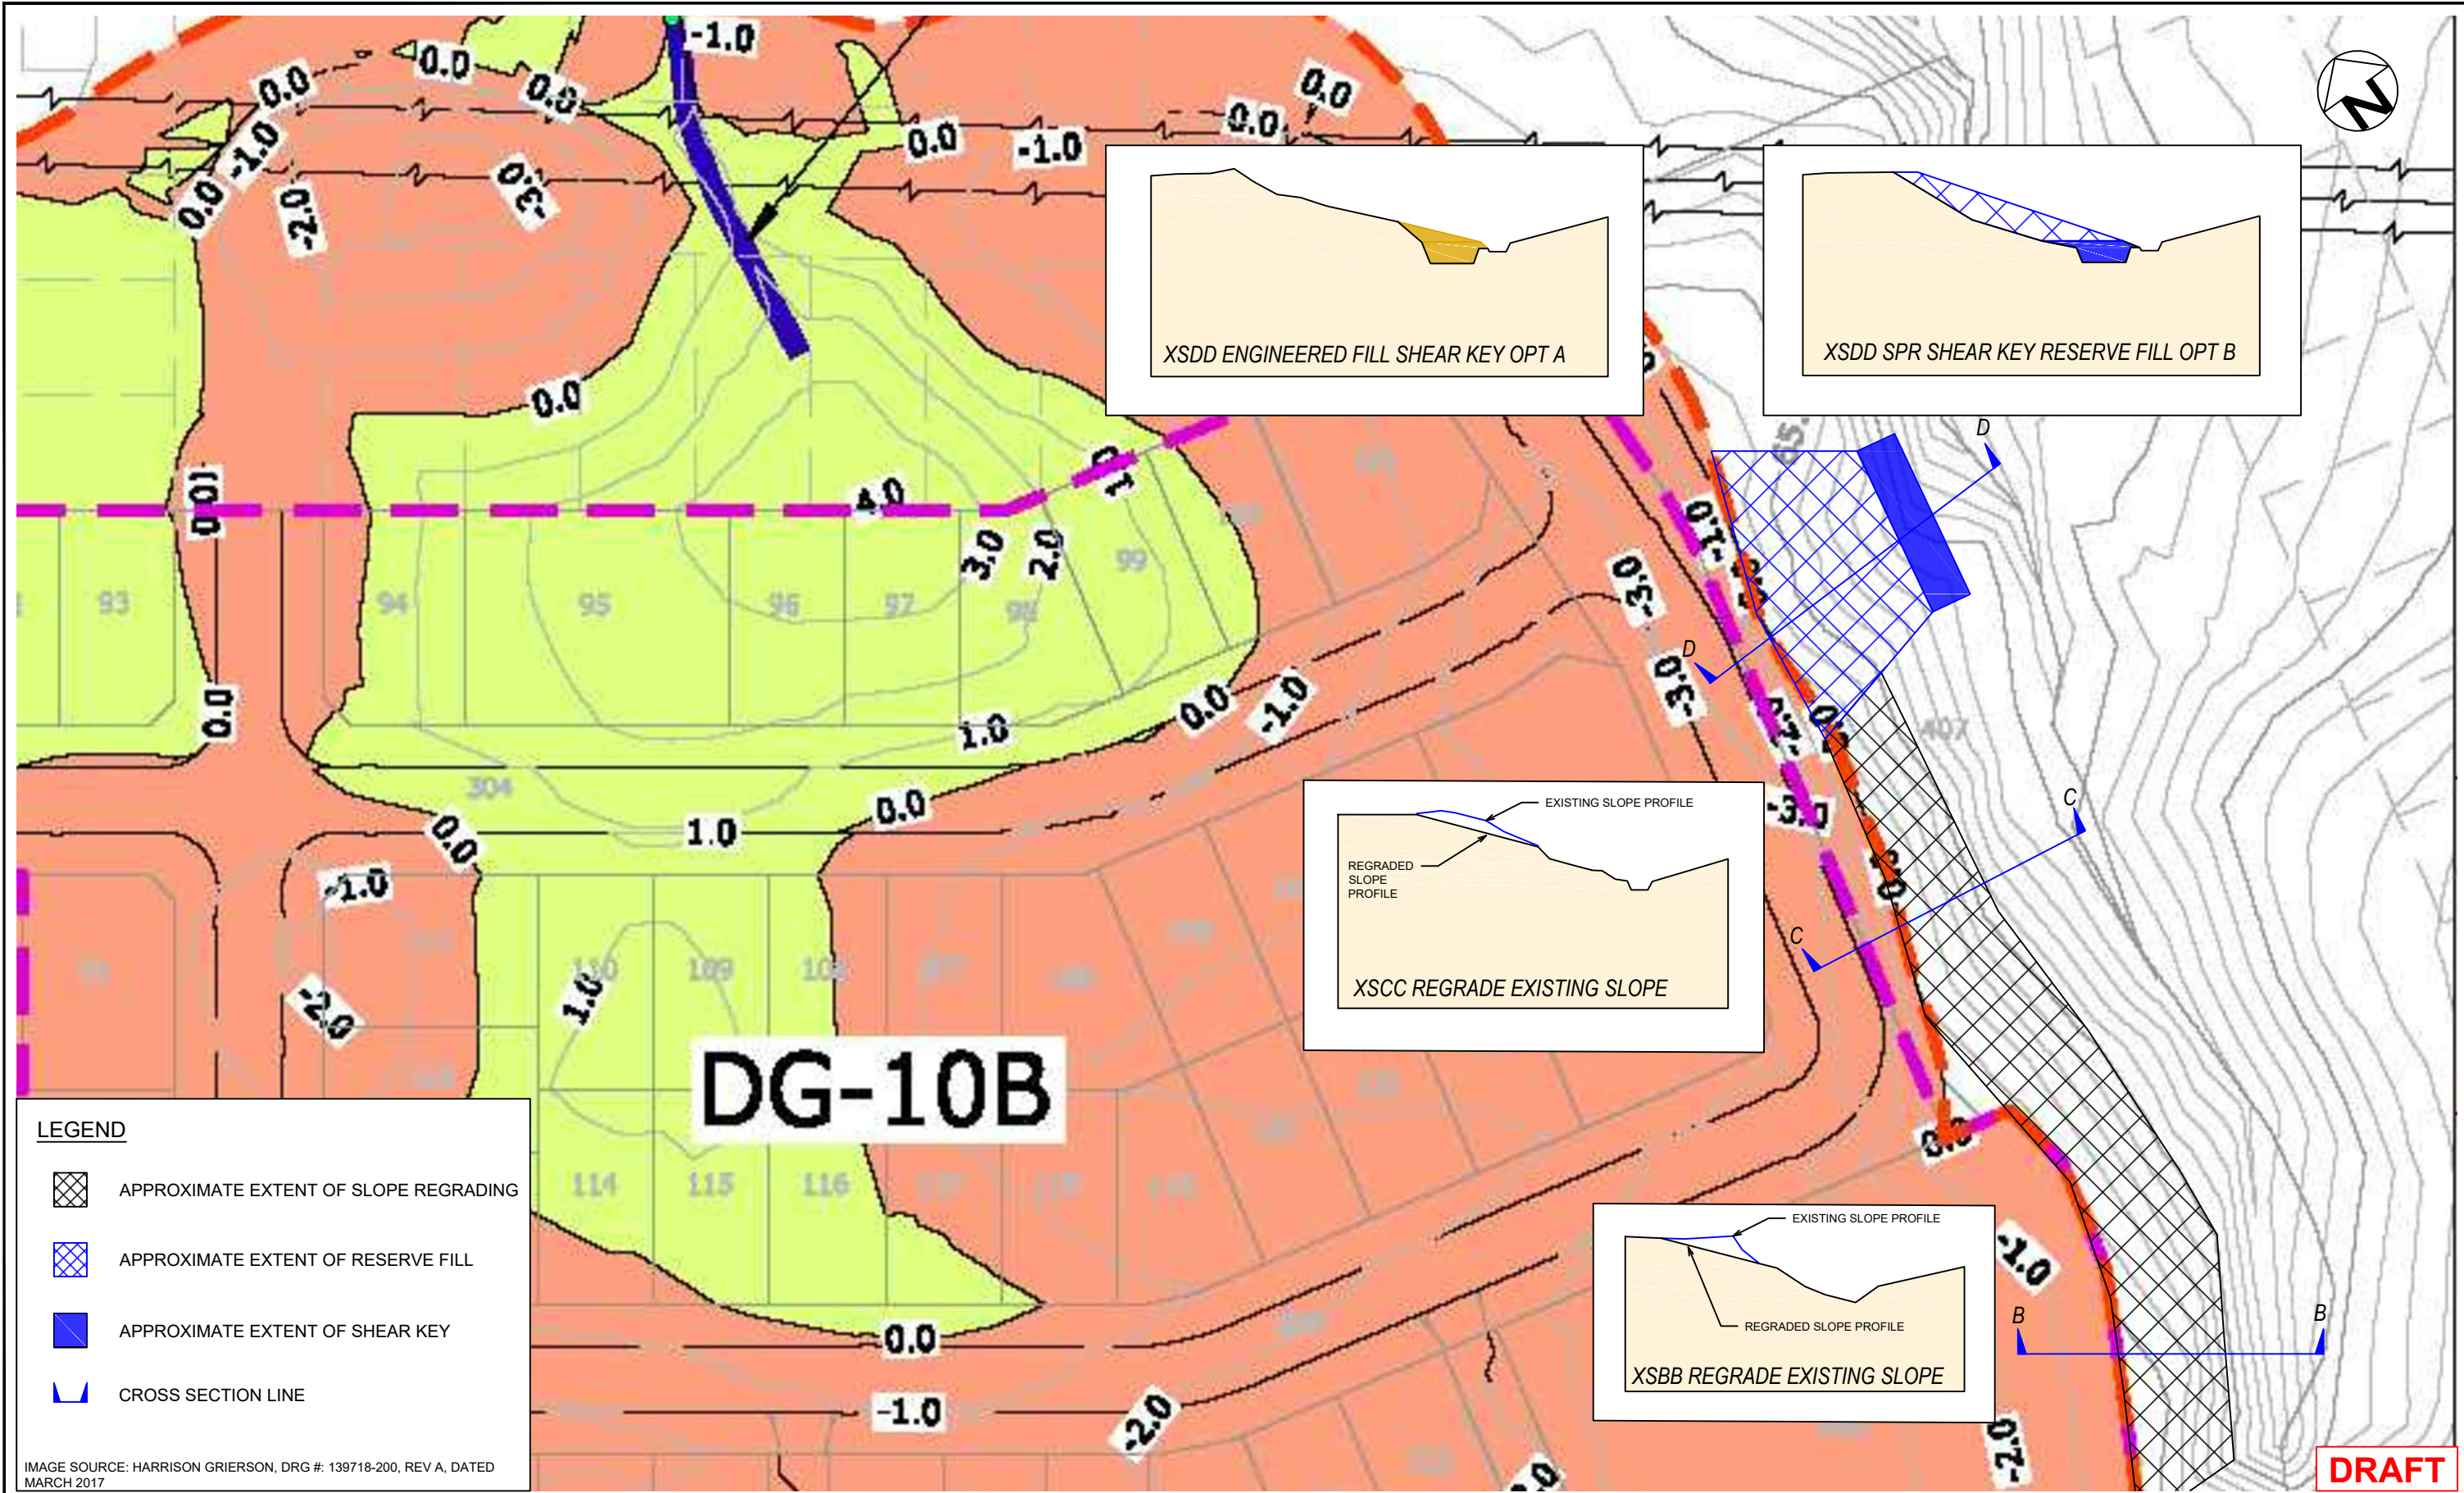
- LEGEND**
- APPROXIMATE EXTENT OF SLOPE REGRADING
 - APPROXIMATE EXTENT OF RESERVE FILL
 - APPROXIMATE EXTENT OF SHEAR KEY
 - CROSS SECTION LINE
