# **Donegal Stud Residential Subdivision Stage 16 at 36 Tir Conaill Avenue, Flat Bush**

## **Geotechnical Completion Report**

**Reference: 773-GENZAUCK16856AE**

20 February 2023

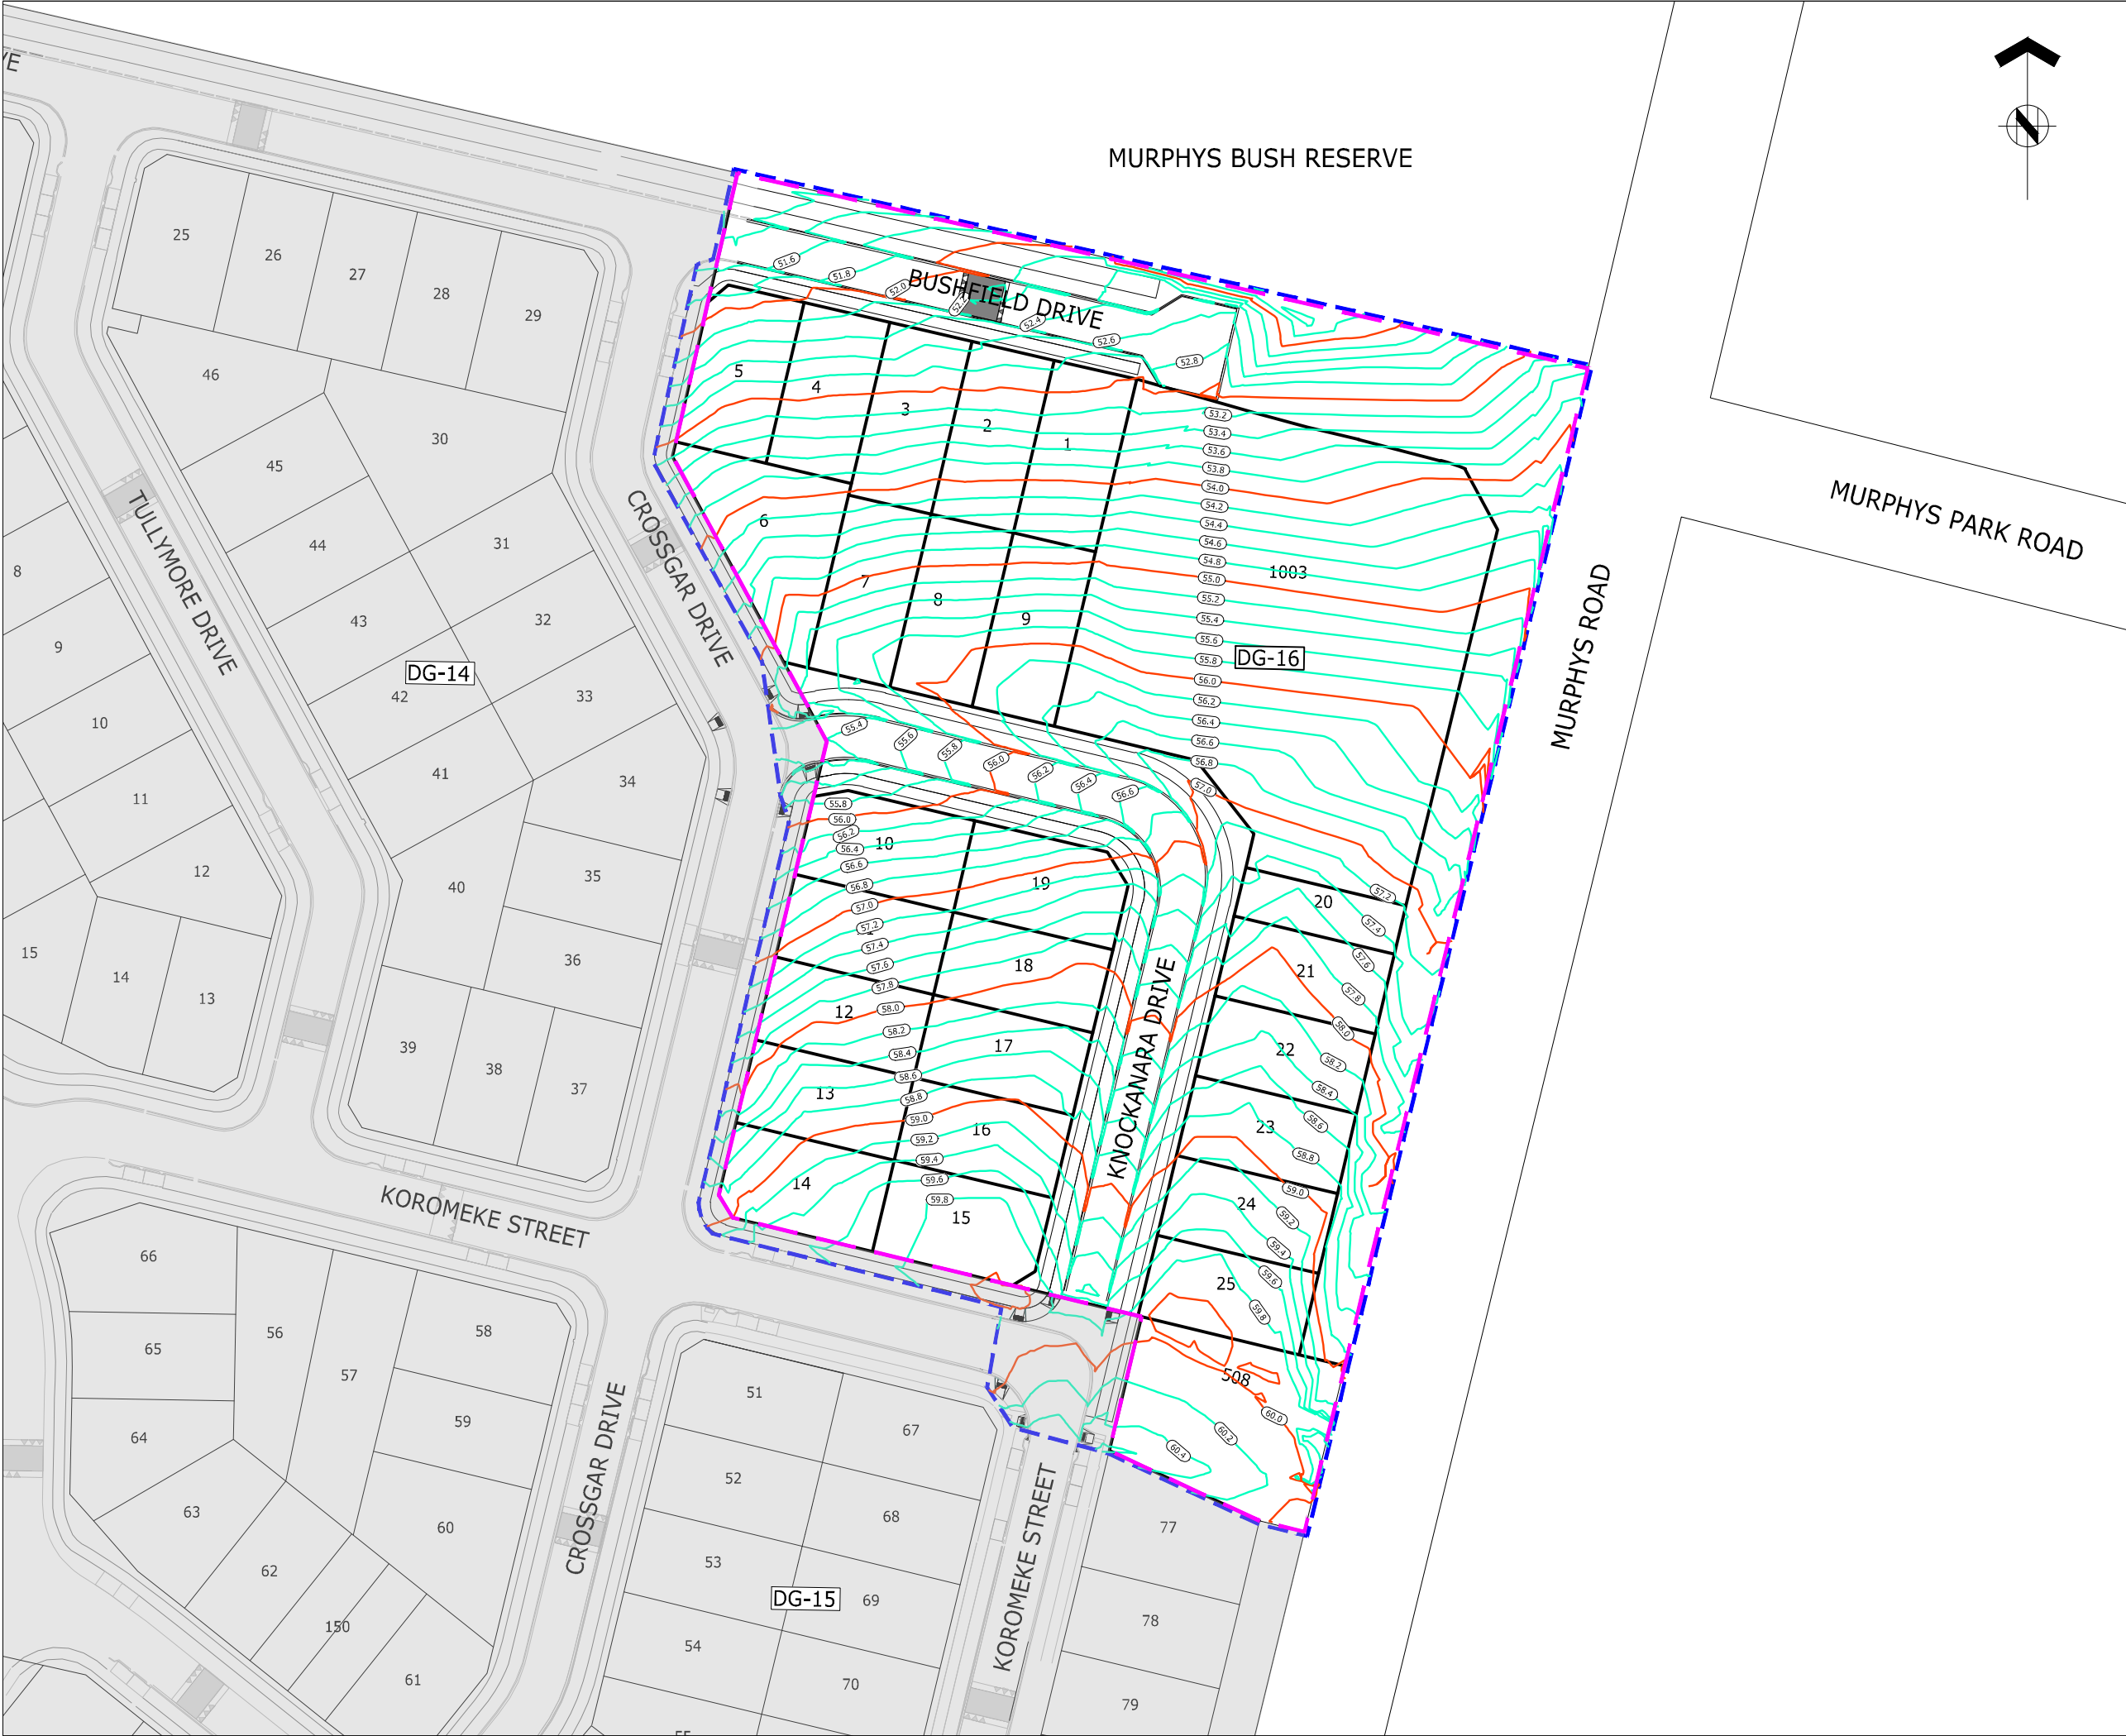
PROJECT No:	SCALES:	A3
A2111813.00	1:500-A1 1:1000-A3	
DRAWING No:		REV
A2111813.00-16-AB200		A

AS-BUILT

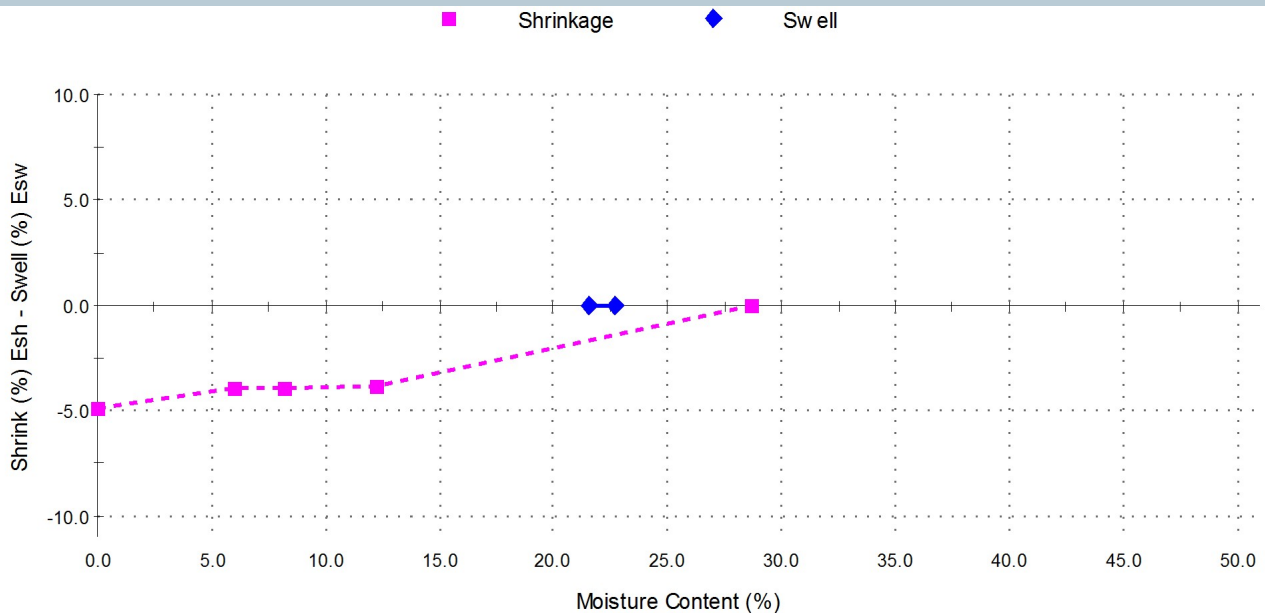
## Shrink Swell

Swell Test AS 1289.7.1.1		Shrink Test AS 1289.7.1.1	
Swell on Saturation (%):	0.0	Shrink on drying (%):	4.9
Moisture Content before (%):	21.6	Shrinkage Moisture Content (%):	28.7
Moisture Content after (%):	22.7	Est. inert material (%):	2%
Est. Unc. Comp. Strength before (kPa):	450+	Crumbling during shrinkage:	0.5%
Est. Unc. Comp. Strength after (kPa):	450+	Cracking during shrinkage:	0.5%

Shrink Swell Index - Iss (%): 2.7

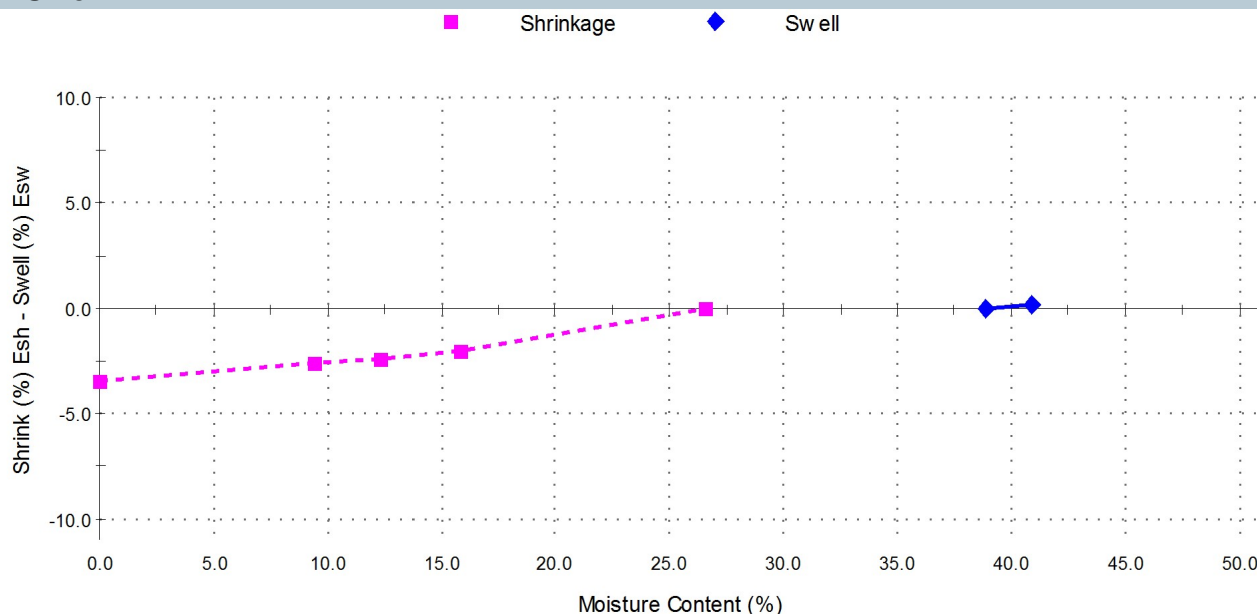
## Shrink Swell

Swell Test AS 1289.7.1.1		Shrink Test AS 1289.7.1.1	
Swell on Saturation (%):	0.1	Shrink on drying (%):	3.5
Moisture Content before (%):	38.9	Shrinkage Moisture Content (%):	26.6
Moisture Content after (%):	40.9	Est. inert material (%):	1%
Est. Unc. Comp. Strength before (kPa):	350	Crumbling during shrinkage:	0.5%
Est. Unc. Comp. Strength after (kPa):	275	Cracking during shrinkage:	1.5%

Shrink Swell Index - Iss (%): 2.0

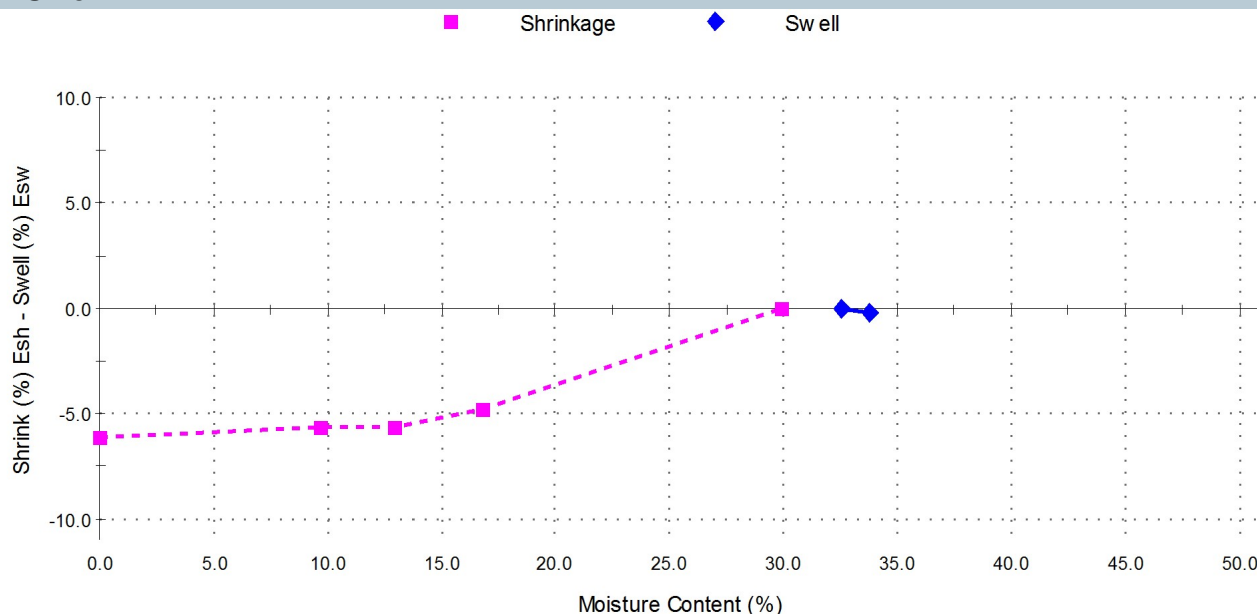
## Shrink Swell

Swell Test AS 1289.7.1.1		Shrink Test AS 1289.7.1.1	
Swell on Saturation (%):	-0.2	Shrink on drying (%):	6.1
Moisture Content before (%):	32.6	Shrinkage Moisture Content (%):	29.9
Moisture Content after (%):	33.8	Est. inert material (%):	15%
Est. Unc. Comp. Strength before (kPa):	275	Crumbling during shrinkage:	3%
Est. Unc. Comp. Strength after (kPa):	175	Cracking during shrinkage:	0.5%

Shrink Swell Index - Iss (%): 3.4

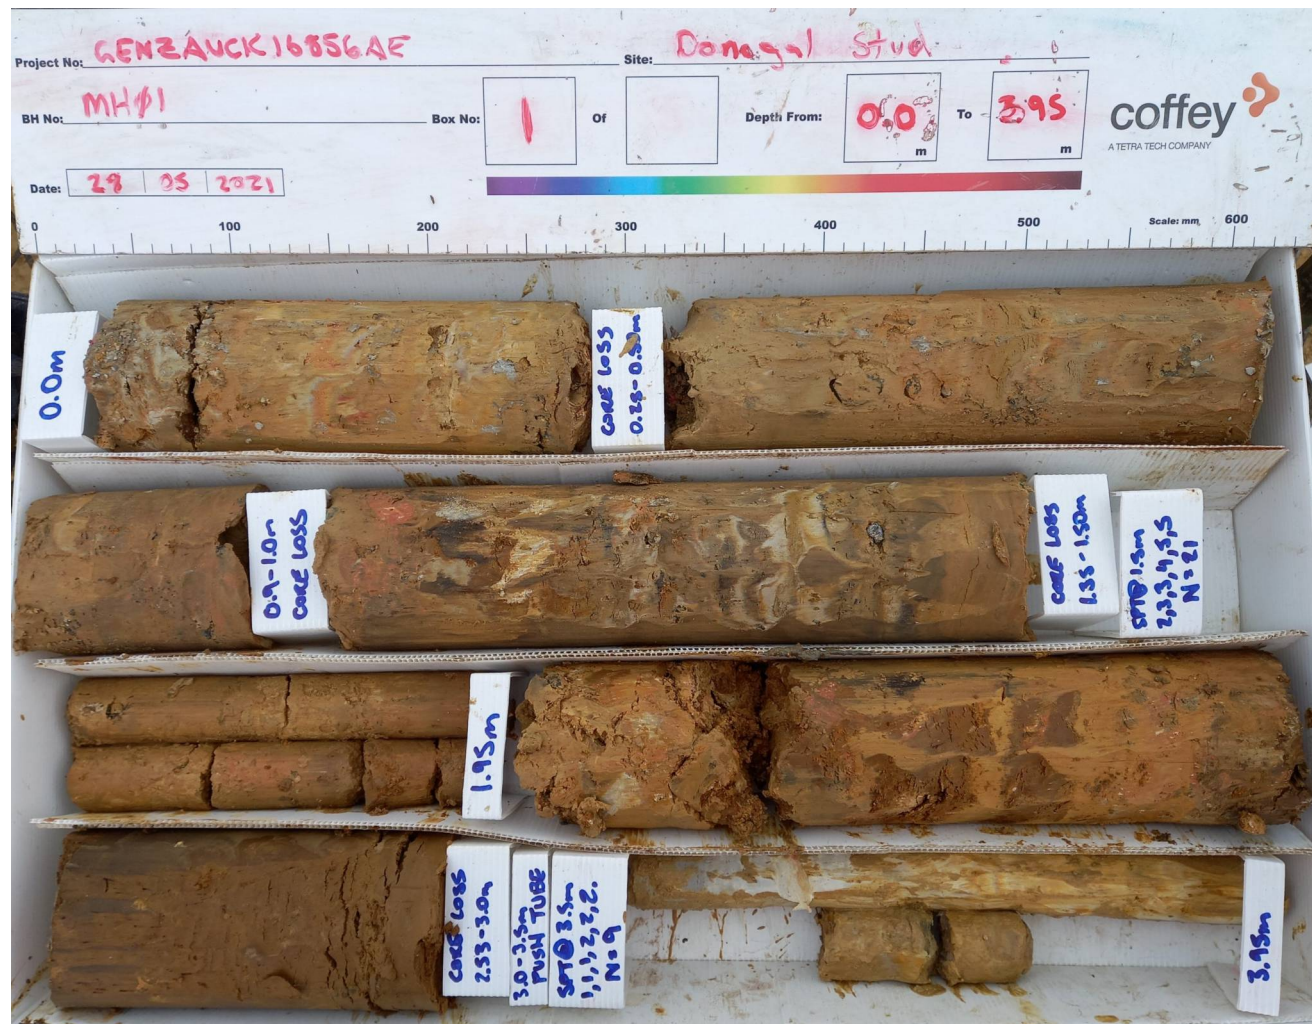
MH01 0.00 - 3.95 m

drawn	EP	<div> </div> <div>TETRA TECH COFFEY</div>	client: Dempsey Wood		
approved	31/05/2021		project: Donegal Stud Stage 14-16 Refer to Site Plan		
date	31/05/2021		CORE PHOTOGRAPH MH01		
scale	N.T.S.		project no: GENZAUCK16856AE		
original size	A4		fig no: <b>FIGURE 1</b> rev:

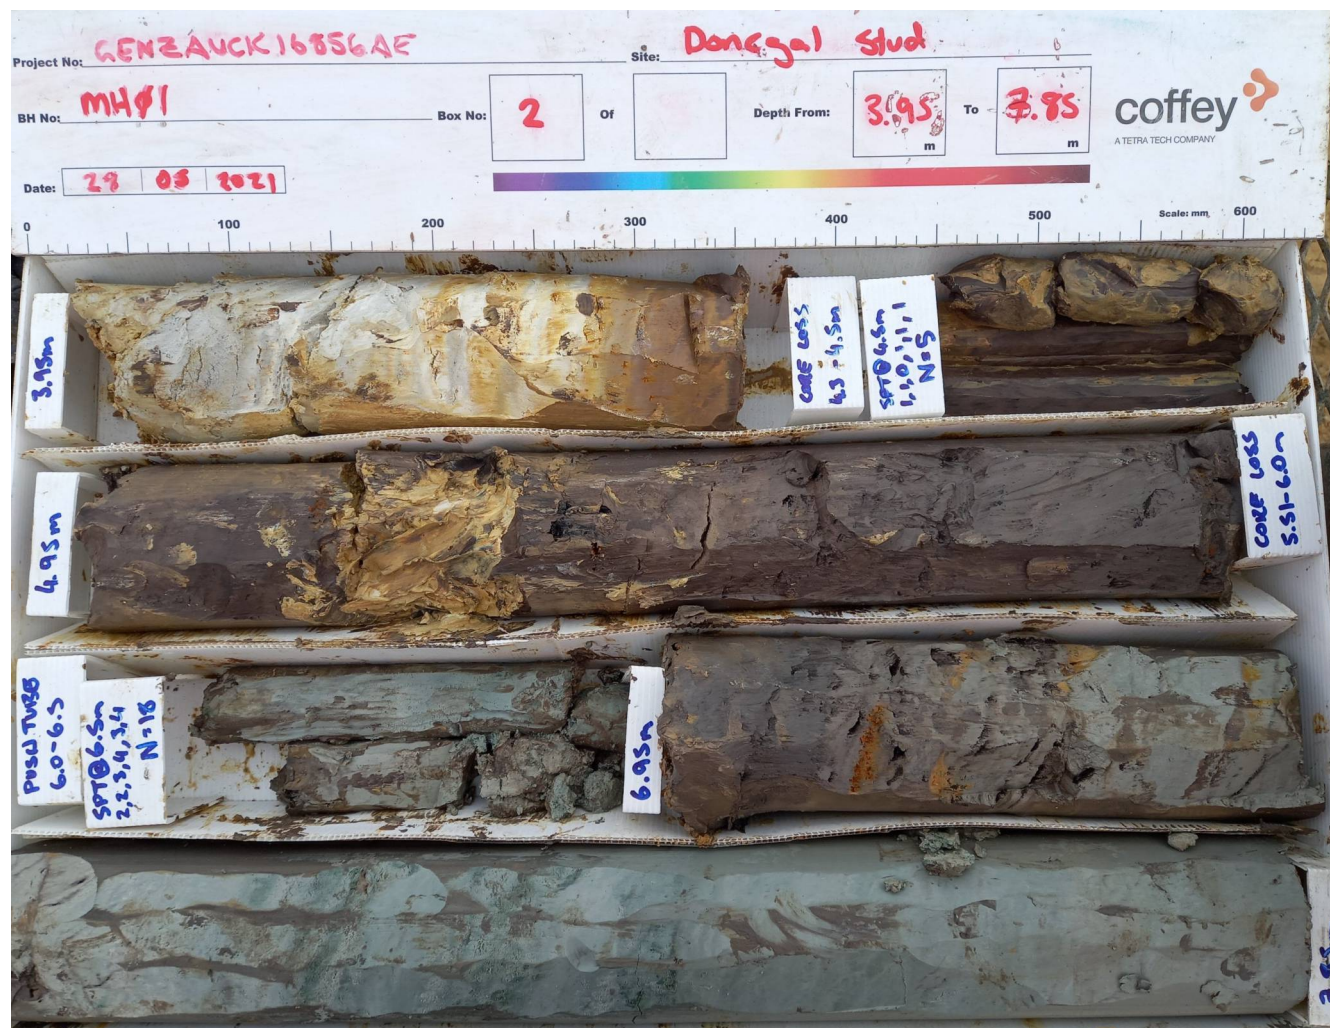
MH01 3.95 - 7.85 m

<b>TETRA TECH</b> COFFEY </div>		
scale	N.T.S.			
original size	A4			
		project no: GENZAUCK16856AE	fig no: <b>FIGURE 2</b>	rev:

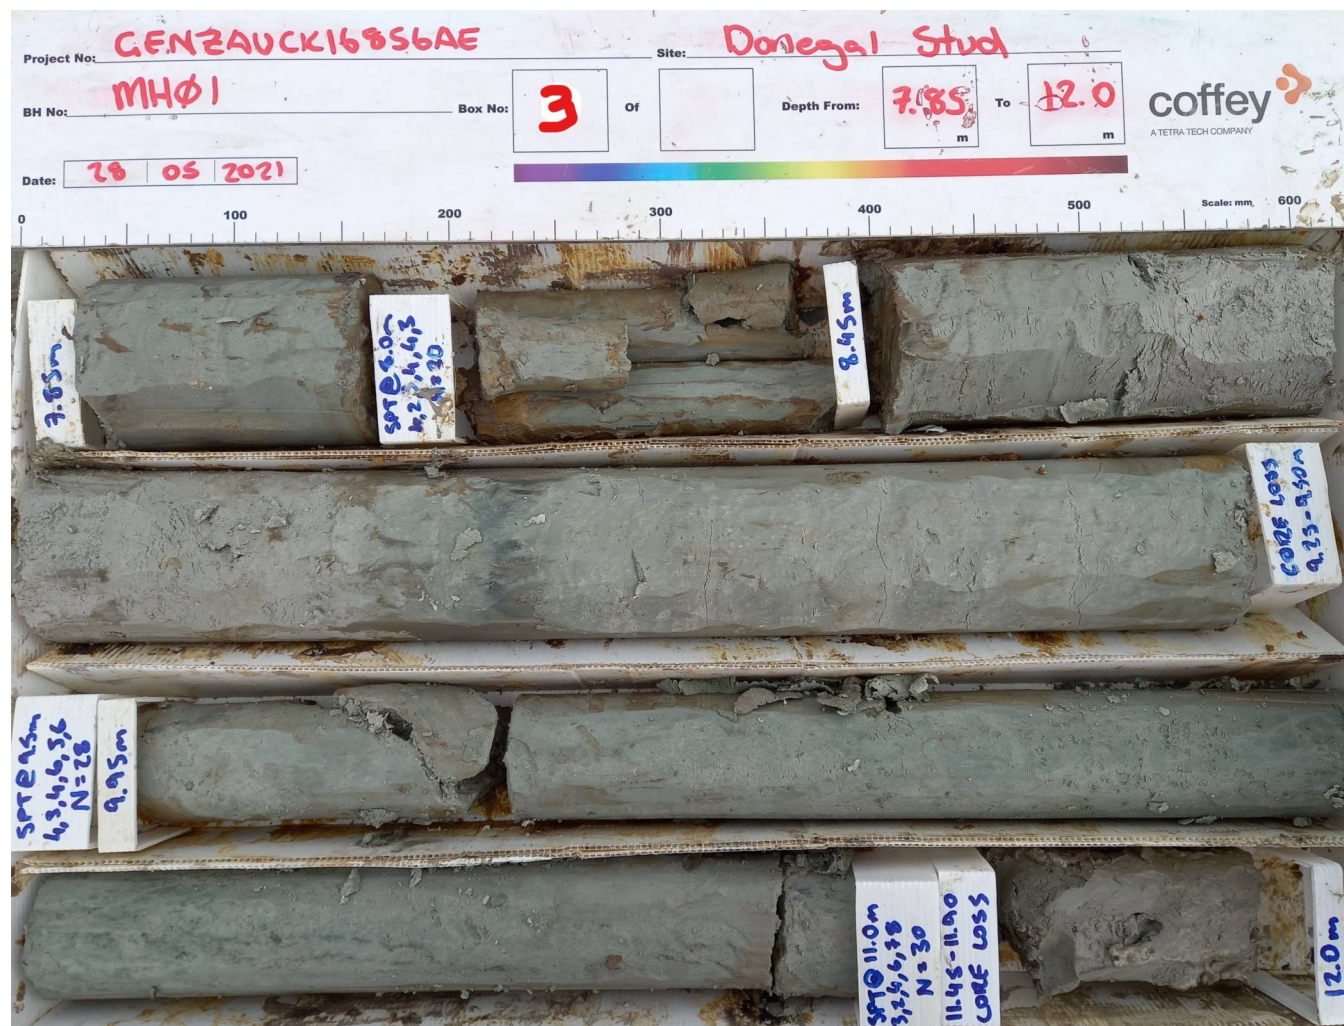
MH01 7.85 - 12.00 m

</div>	
scale	N.T.S.		
original size	A4		
		CORE PHOTOGRAPH MH01	
		project no: GENZAUCK16856AE	fig no: <b>FIGURE 3</b>
		rev:

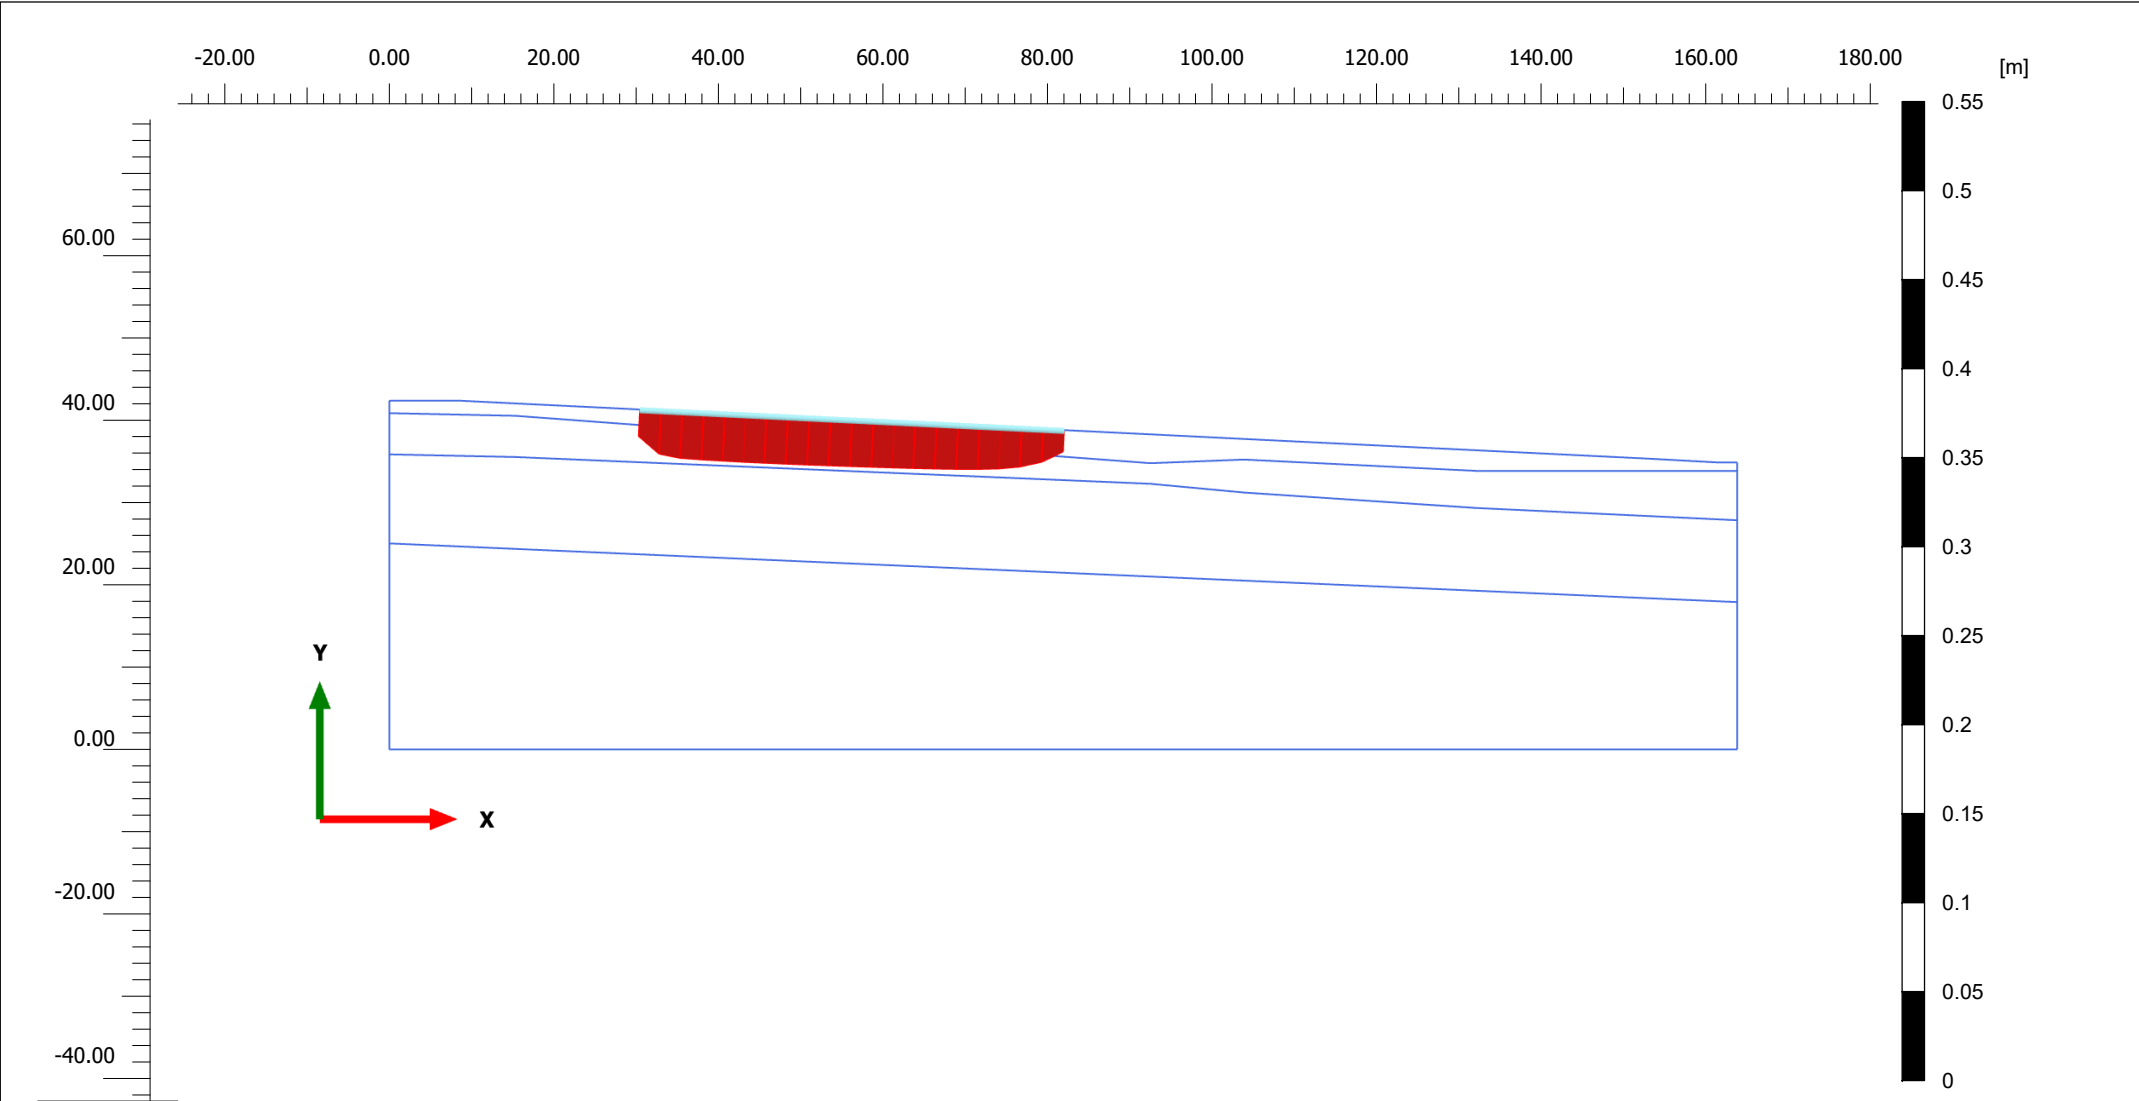
**Total displacements  $u_y$  (scaled up 200 times) (Time 0.4331 day)**

Maximum value = -0.01268 m
