14 August 2017

Our ref: 773-GENZTAUC12590AC-AD

**Geotechnical Completion Report for Lots 33 to 37, Bob Carter Place, Welcome Bay**

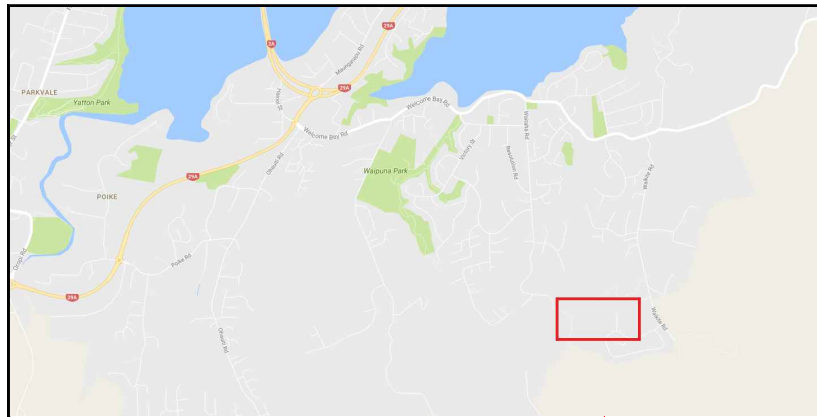
client:	HUGH GREEN CONTRACTORS LTD		
project:	BALLINTOY PARK SUBDIVISION STAGE 5B - LOTS 33 TO 37 GEOTECHNICAL COMPLETION REPORT		
title:	SITE LAYOUT		
project no:	GENZTAUC12590AC	figure no:	01
rev:	0

The extent of earthworks supervised by Coffey is shown on the appended plans (Figures 01 to 05, Appendix A). A Geotechnical Suitability Statement and a Producer Statement (PS-4) for the works described herein are also appended.

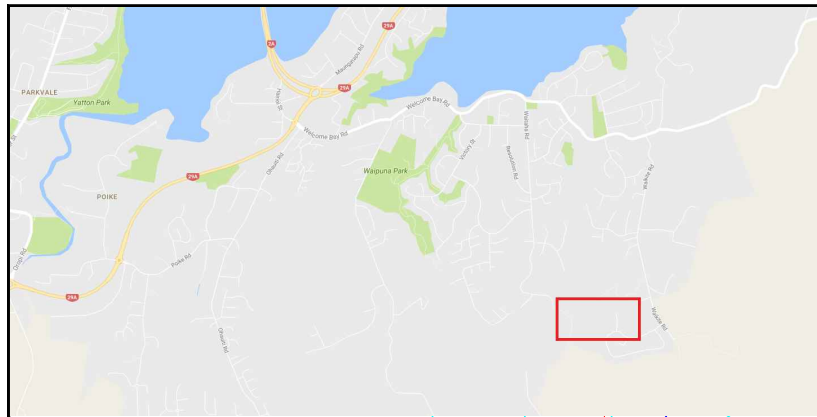
client:	HUGH GREEN CONTRACTORS LTD		
project:	BALLINTOY PARK SUBDIVISION STAGE 5B - LOTS 33 TO 37 GEOTECHNICAL COMPLETION REPORT		
title:	PRE-2017 DEVELOPMENT CONTOUR PLAN		
project no:	GENZTAUC12590AC	figure no:	03
rev:	0

The existing topography within the subject site prior to the most-recent (2017) earthworks was generally uniform and gently sloping to the west, at approximately 1V:5H to 1V:8H. To the west of the subject site however, the topography steepened to approximately 1V:2H towards a steep gully off the Waiorakei Stream. The development landform prior to the most-recent earthworks is depicted on the Pre-2017 Contour Plan (Figure 03) in Appendix A.

- 2 Test pits excavated to a depth of up to 5.4m, and 1 borehole drilled to a depth of 10.95m, to assess the subsurface conditions in 2015 (Coffey, TP510, TP511, and BH501 on Figure 03).

- 1 Hand auger borehole and 5 CPTs drilled to a depth of 4m, to assess the subsurface conditions in 2016 (Coffey, HA01 and CPT01 to CPT05, on Figure 03).

- 2 Hand auger boreholes drilled to a depth of 4m, and 5 CPTs drilled to a depth of 10m in 2016. The investigations were undertaken to assess the subsurface conditions for the design of the four retaining walls (Coffey, HA02 and HA03, CPT06 to CPT10, on Figure 03).
