# STAGE 5 BALLINTOY PARK SUBDIVISION 26 & 28 BALLINTOY PARK DRIVE, WELCOME BAY

## **GEOTECHNICAL COMPLETION REPORT**

Hugh Green Group Limited Ref. TGA2016\_0121AB Rev0

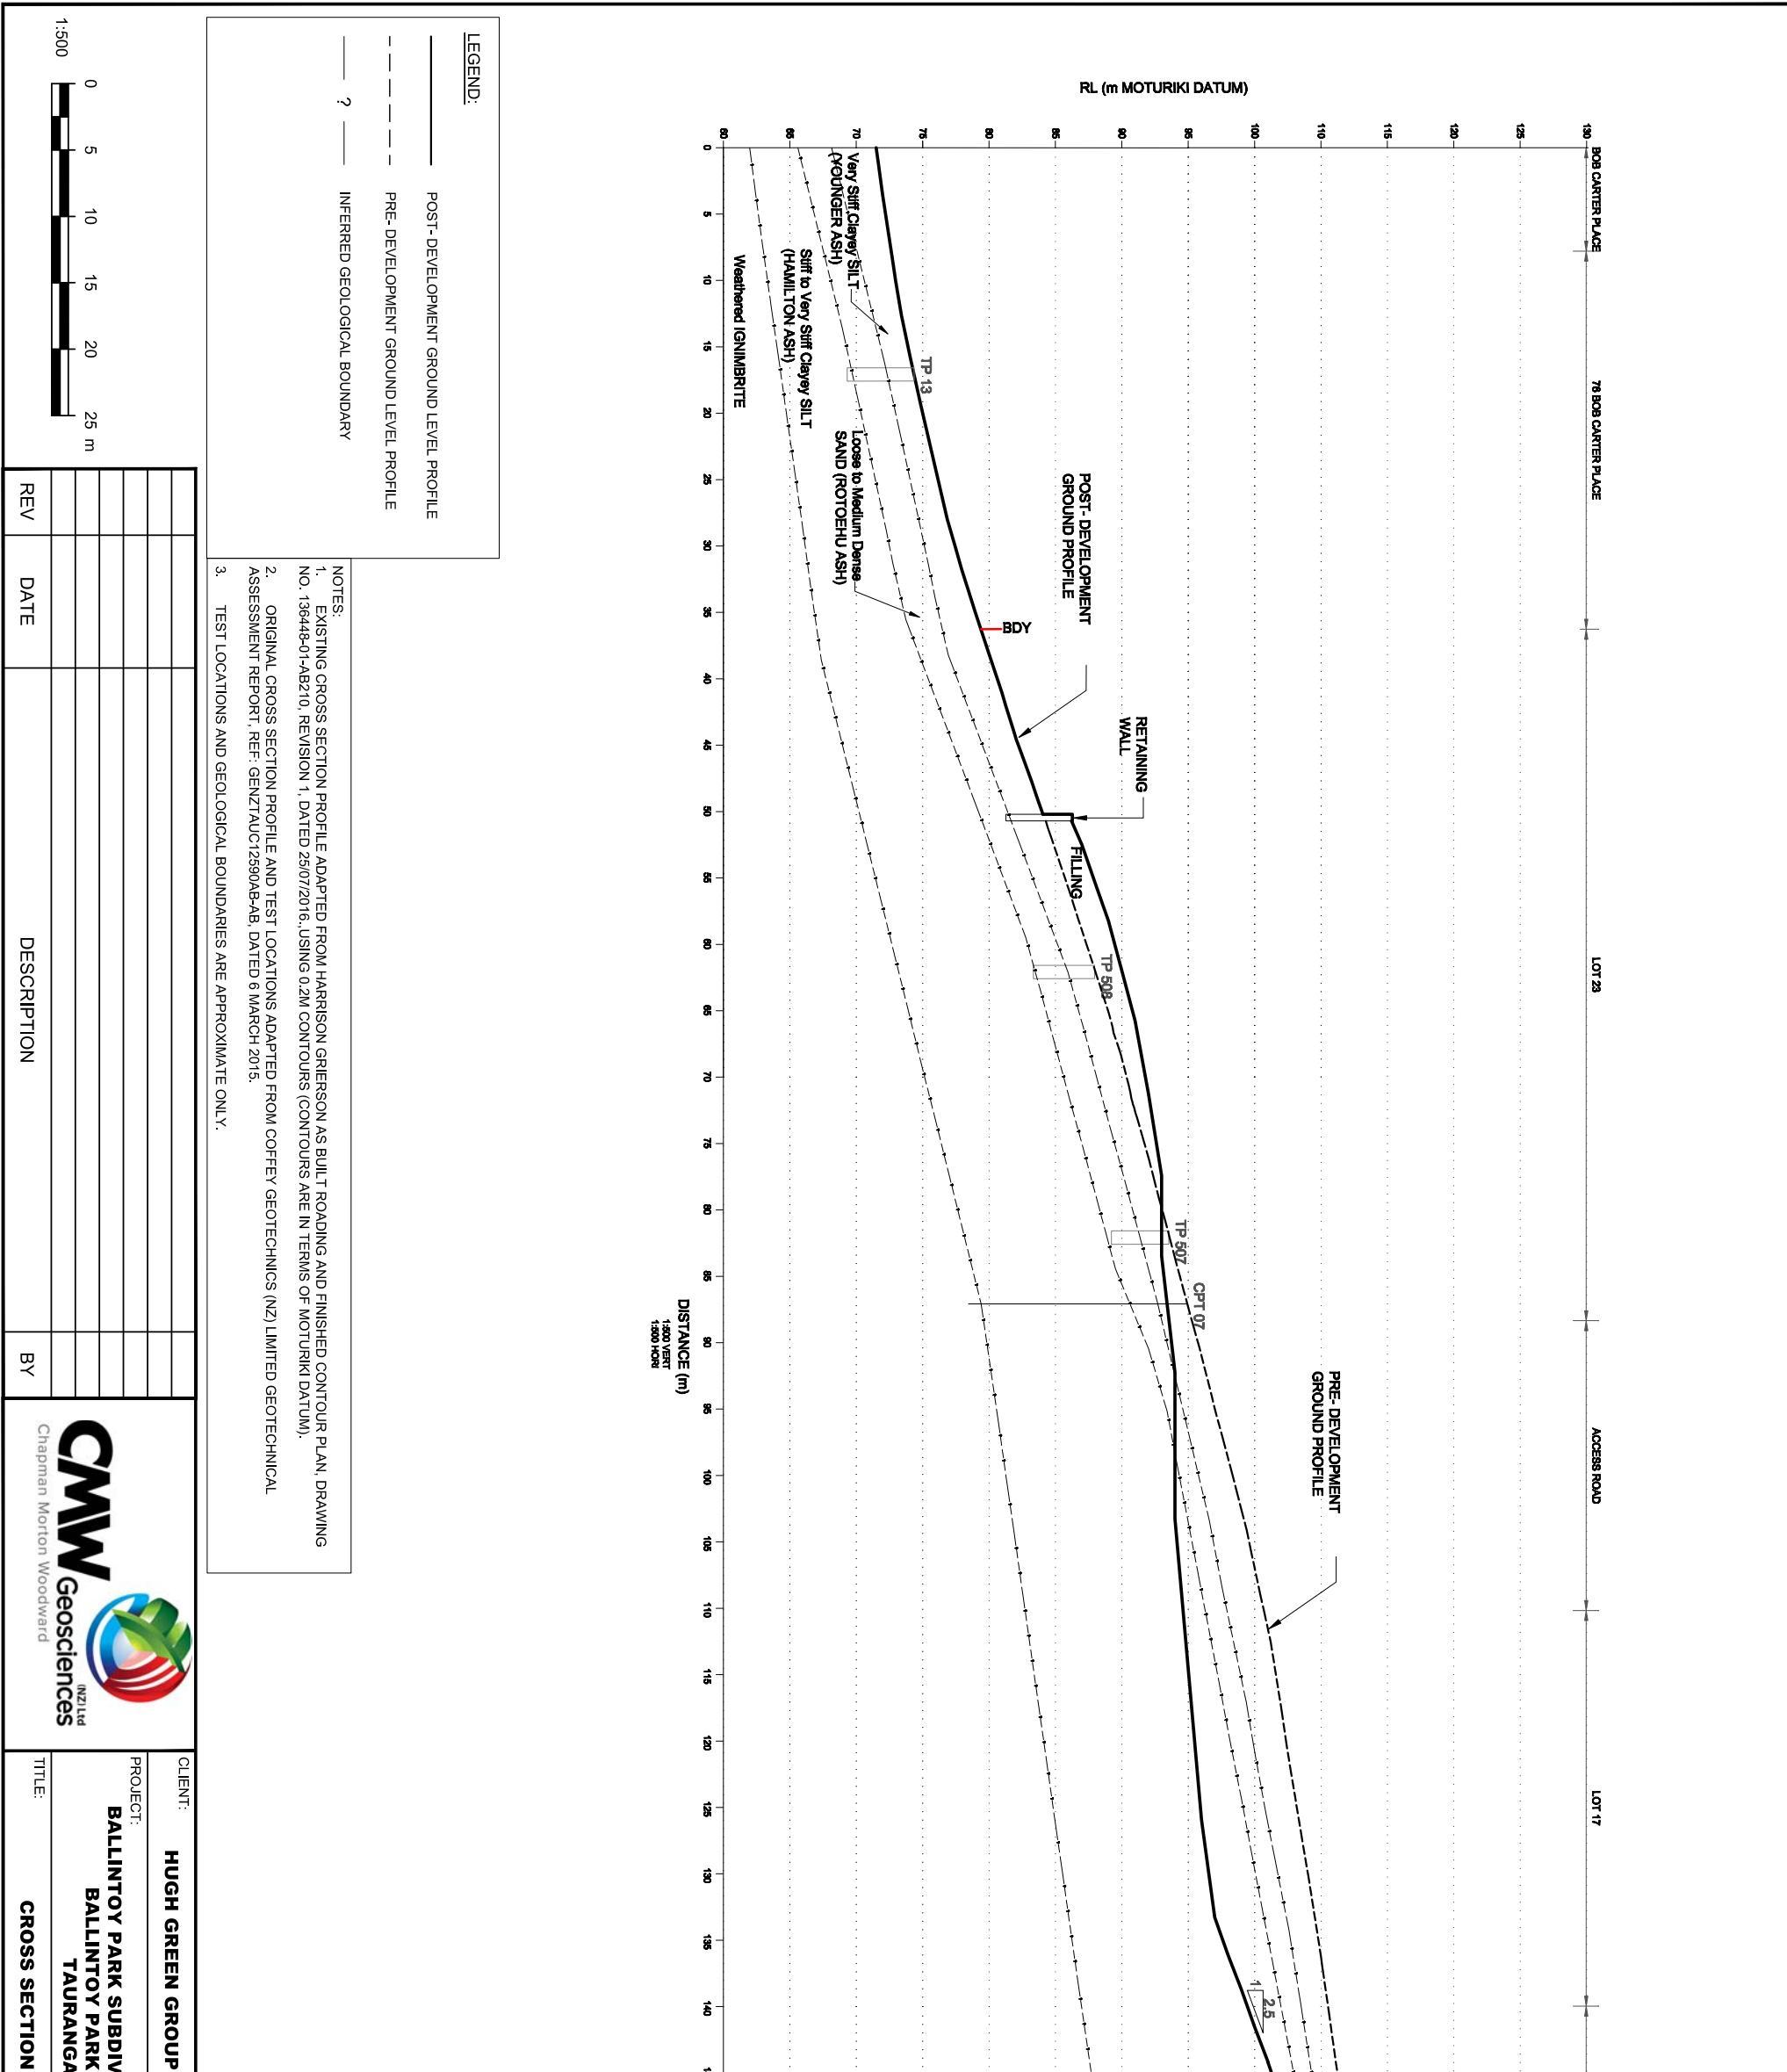
Slope stability analyses were completed by Coffey for the design cut batter above lots 15 to 19 inclusive. These showed that to achieve the minimum required factors of safety for slope stability, a maximum allowable gradient of 1:2.5 (vertical to horizontal) was recommended as depicted on the appended Cross Section A-A (Figure 04).
